REPORT OF COAL-MINE BUMP ACCIDENT
MOSS NO. 2 MINE
CLINCHFIELD COAL COMPANY
CLINCHFIELD (P.O. DANTE), RUSSELL COUNTY, VIRGINIA

January 8, 1970

by

J. L. Gilley

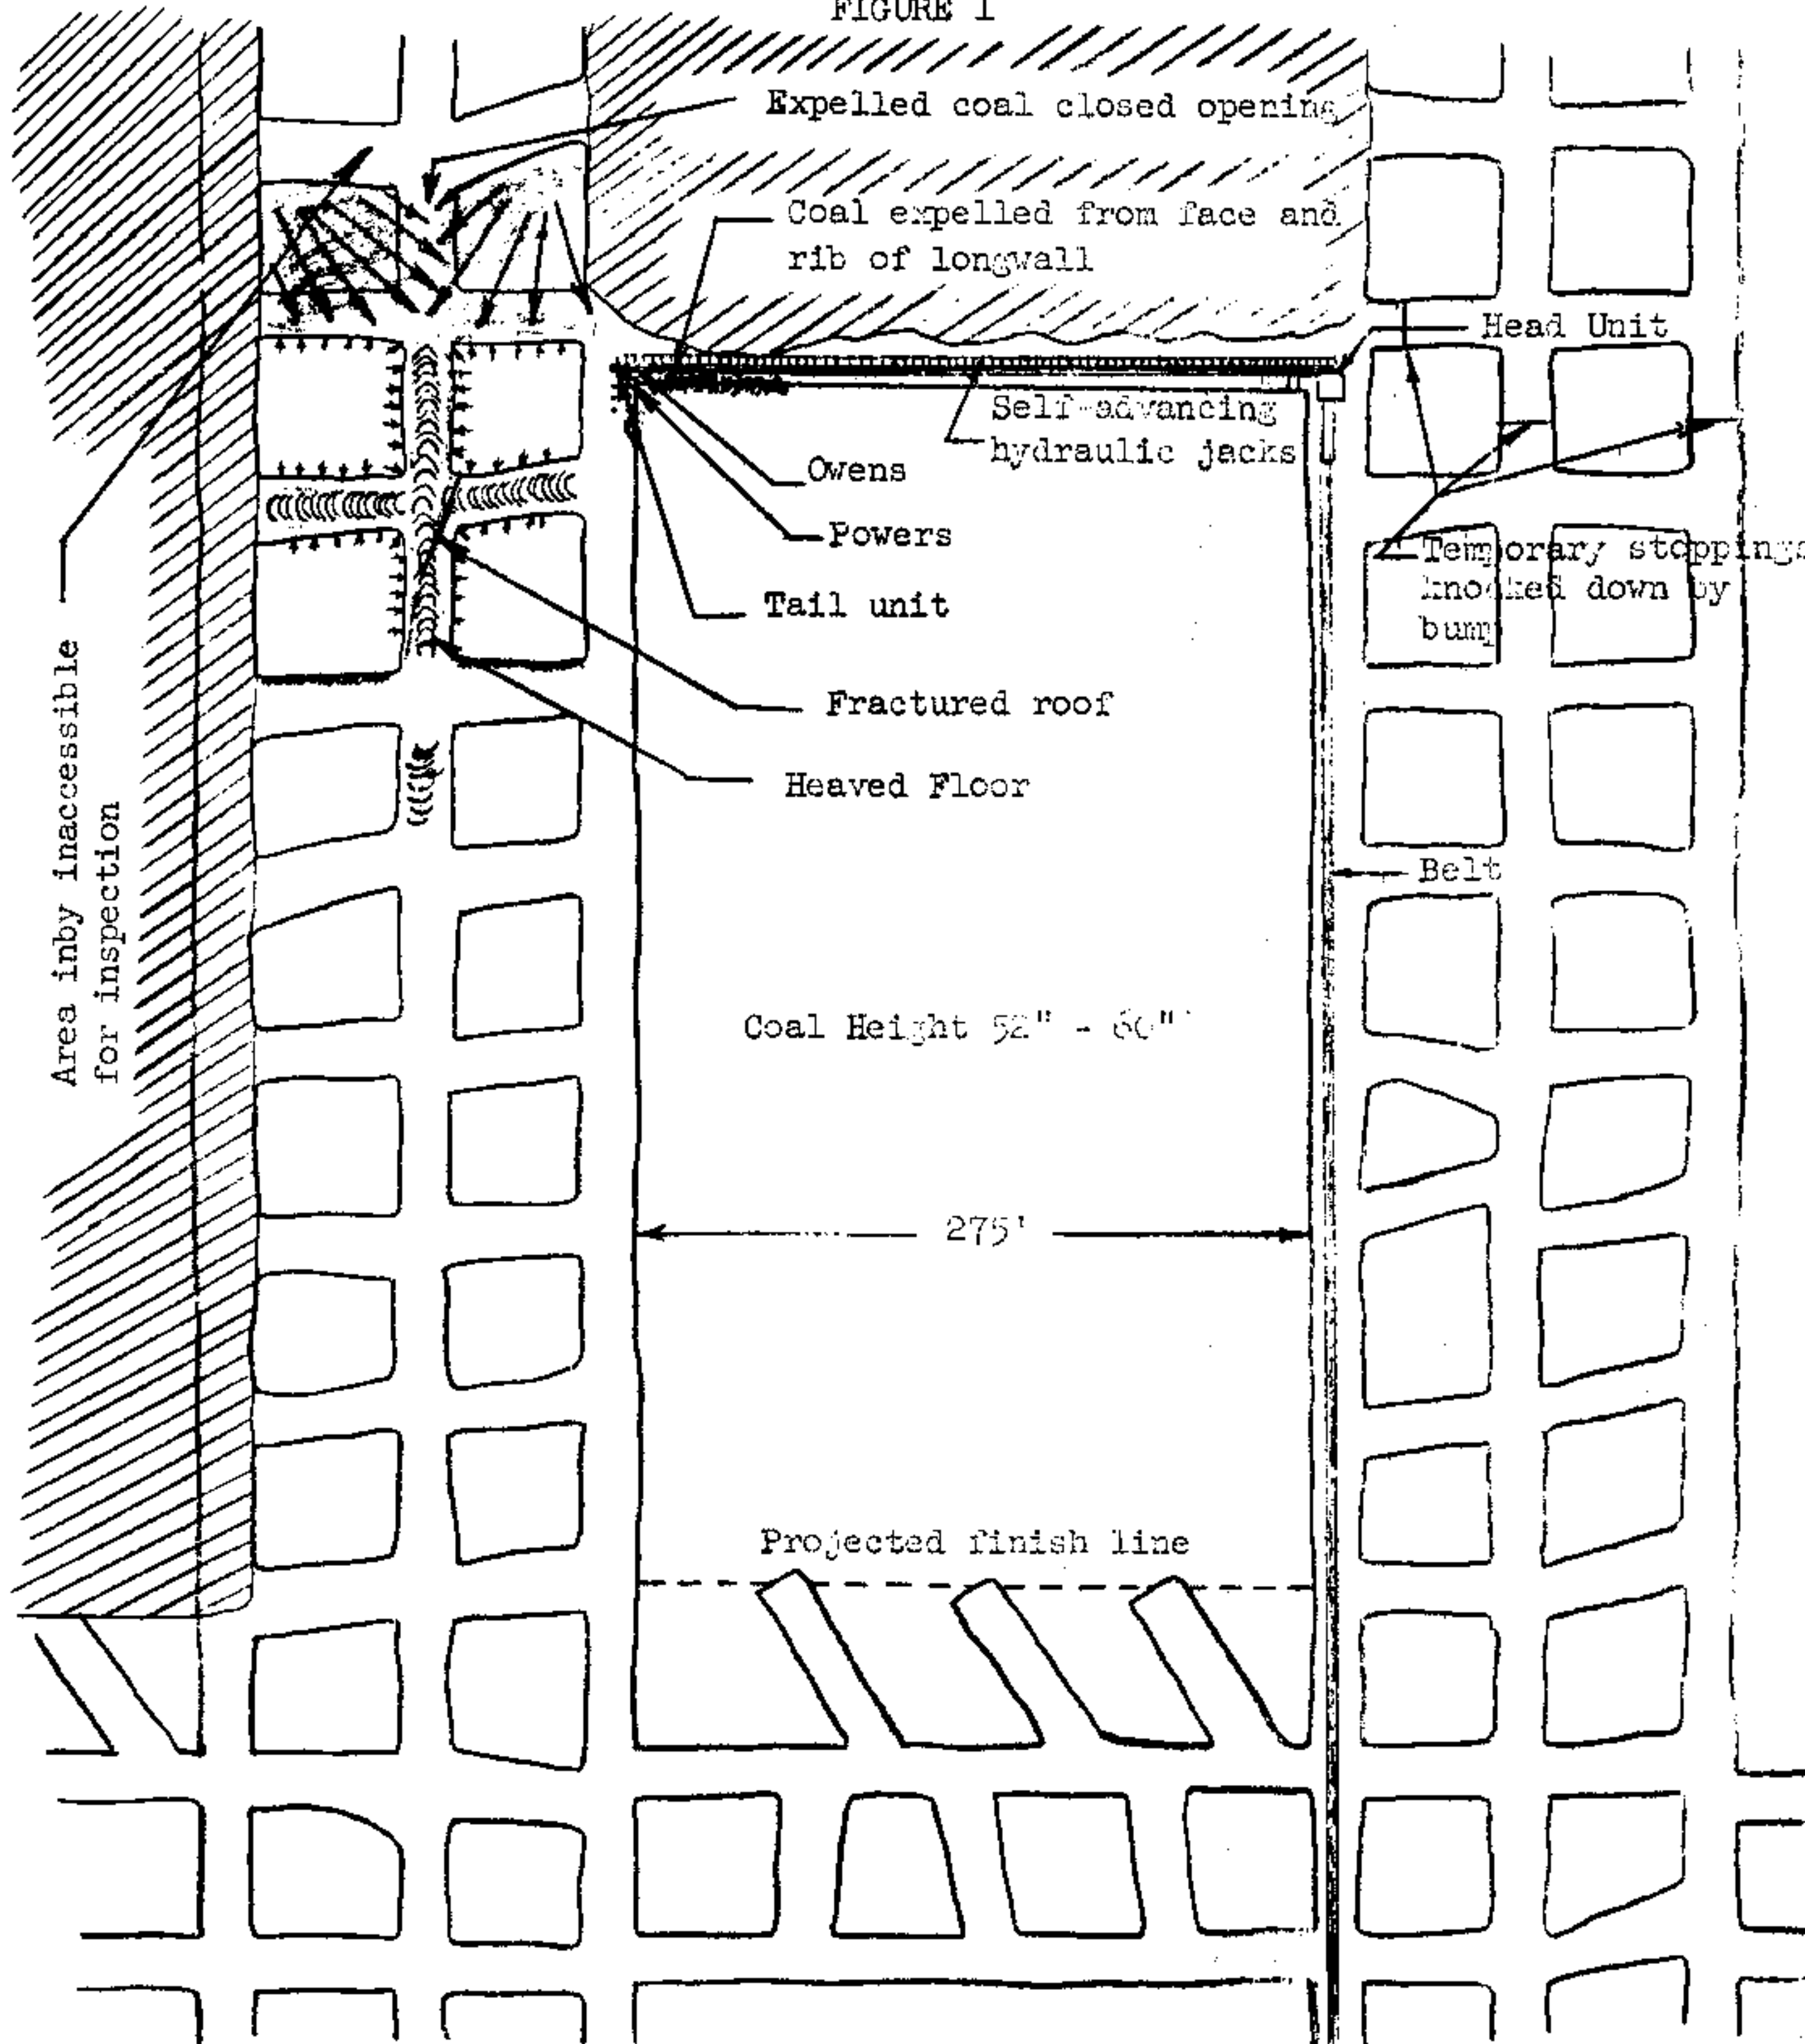
FIGURE 1

Six of the tail-entry chain pillars adjacent to and slightly inby the conveyor tail-drive unit were affected. Coal was expelled violently from 2 of the pillars; the entry between them was completely filled with pulverized coal, leaving voids, 6 to 10 inches in height that extended several feet into these pillars. The other 4 pillars were affected to lesser degrees. Pronounced floor heave occurred in the entry between these 6 pillars and to some extent at two locations in the tail entry outby the longwall face.

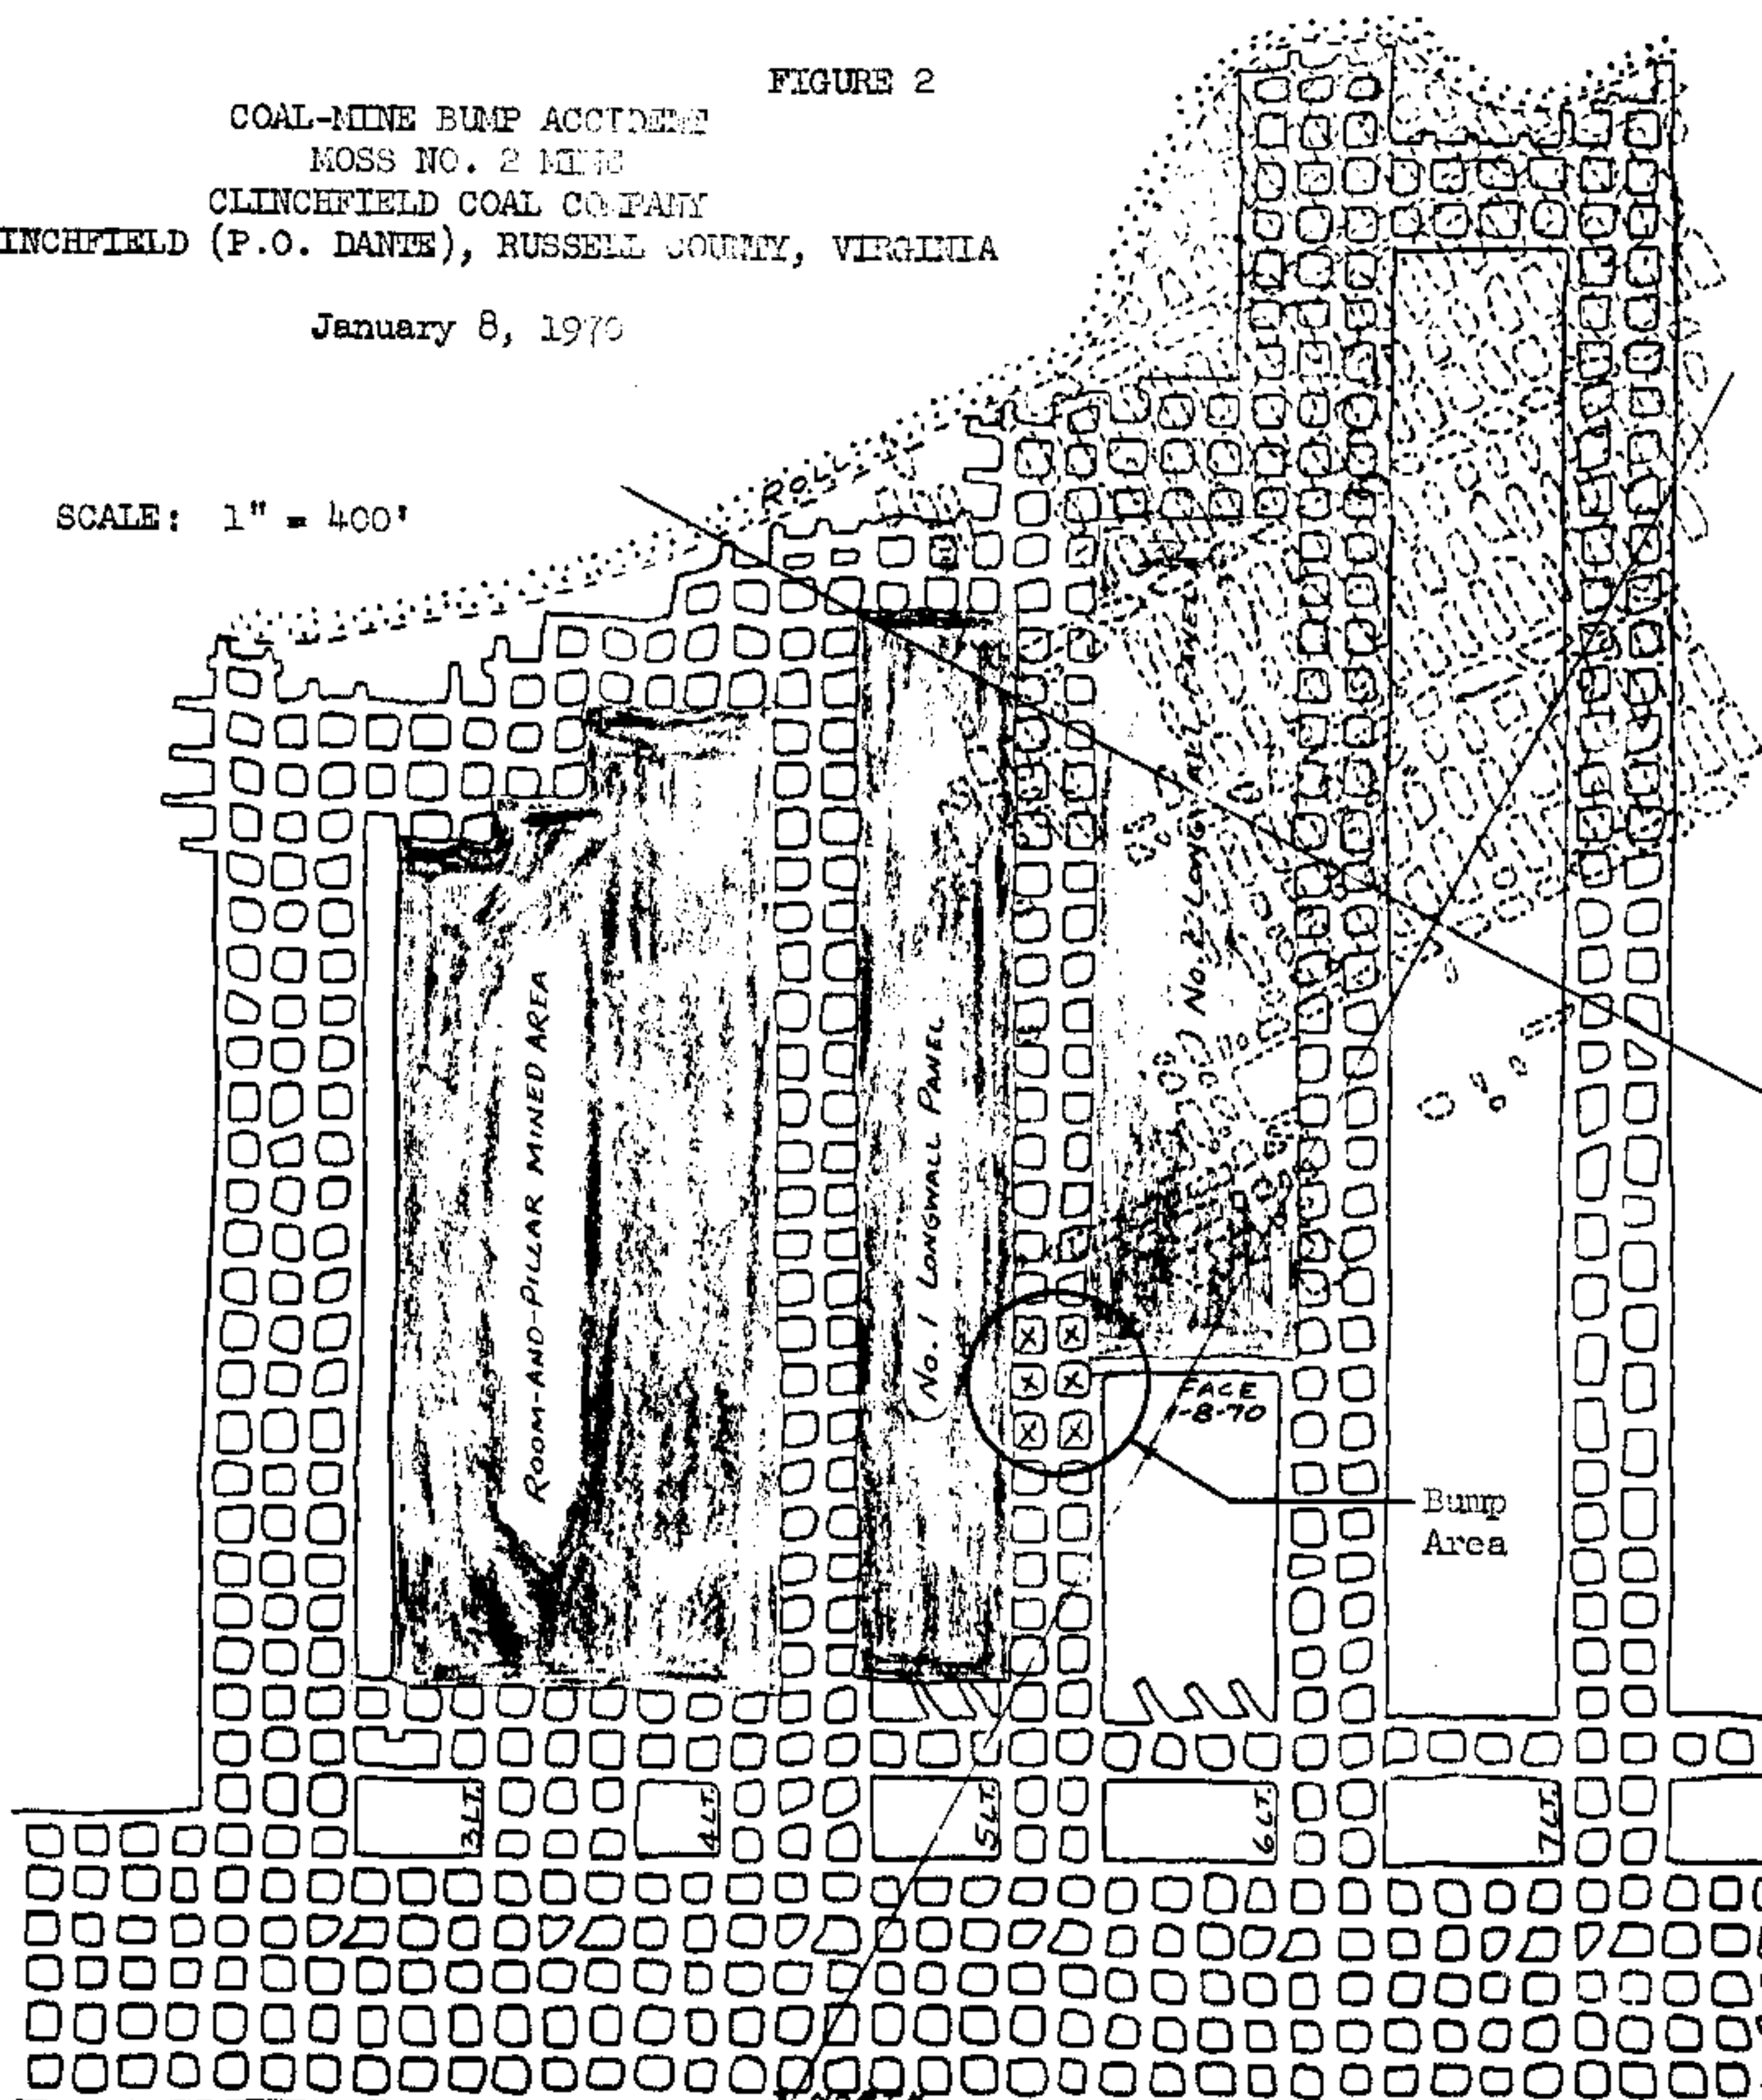
FIGURE 2

From Figure 2, it will be noted that total mining in the area, at the time, comprised adjacent panels of varying widths and lengths. It was postulated that the subsequent caving that had occurred up to the time of the bump, terminated at different horizons in the respective panel gob areas; this caving possibly was limited to the immediate and secondary strata in some areas of the goaves. This restrictive caving probably resulted in the establishment of comparatively flat arches acting as flat beams or plates across the chain pillars intervening between the contingent goaves of the mined-out panels and the current longwall. From Figure 2, it will be noted that chain pillars between Nos. 1 and 2 panels were situated in zones of superimposed abutment pressures within the maximum pressure arch. Loads on the pillars affected, increased progressively by build-up of pressures from the incremented dimensional increase of the void area. Reportedly, difficulty had been experienced from intermittent fracturing of the roof in the front prop-free space of the longwall for several weeks prior to the bump; however, during the investigation, no unusual stressed conditions, except localized floor upheavals in the Nos. 1 and 2 tail entries, were evident outby the longwall face.

Inspection of the company's overlay maps incorporating the area involved in the bump in the Tiller coalbed and the corresponding areas in the superjacent Upper Banner and the Lower Banner coalbeds, revealed that the 6 left longwall had recently retreated out from under a group of unmined pillars in the Upper Banner coalbed. Figure 2 indicates the relative positions of the 6 left longwall face in the lower bed and the unmined pillars in the overlying bed at the time the bump occurred.

The interval between the group of unmined pillars in the Upper Banner coalbed and the area involved in the bump in the Tiller coalbed, was 850 feet. From Figure 2, it will be further noted that the general arrangements of these isolated unmined pillars formed an island abutment and that the pillars showed considerable variations in shape and size. Elevation of the 6 left longwall area was 1,425 feet; elevation of the area of the isolated coal pillars in the Upper Banner coalbed was 2,273 feet and the elevation of the surface over these areas was 2,330 feet.
